# GALVESTON LABORATORY PRESERVATION PLAN

NOAA / NMFS  
Galveston, TX

Prepared  
for the  
National Oceanic and  
Atmospheric Administration

Design Constructs  
437 Humphrey Street  
New Haven, CT 06511-3710

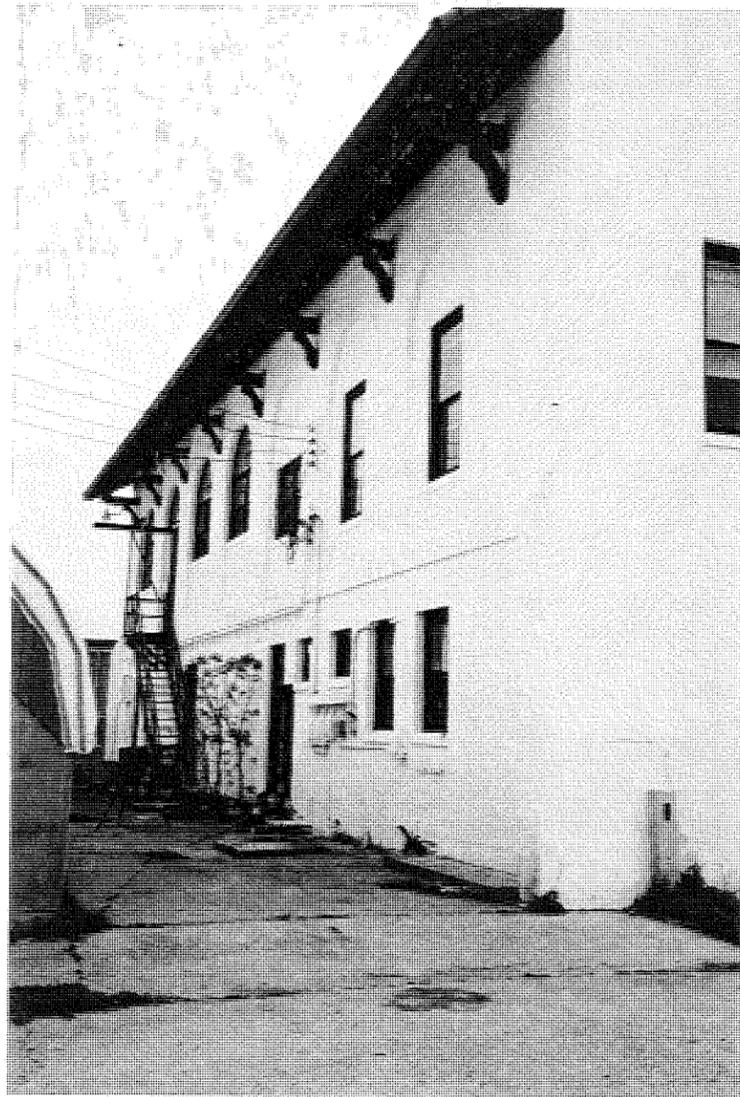
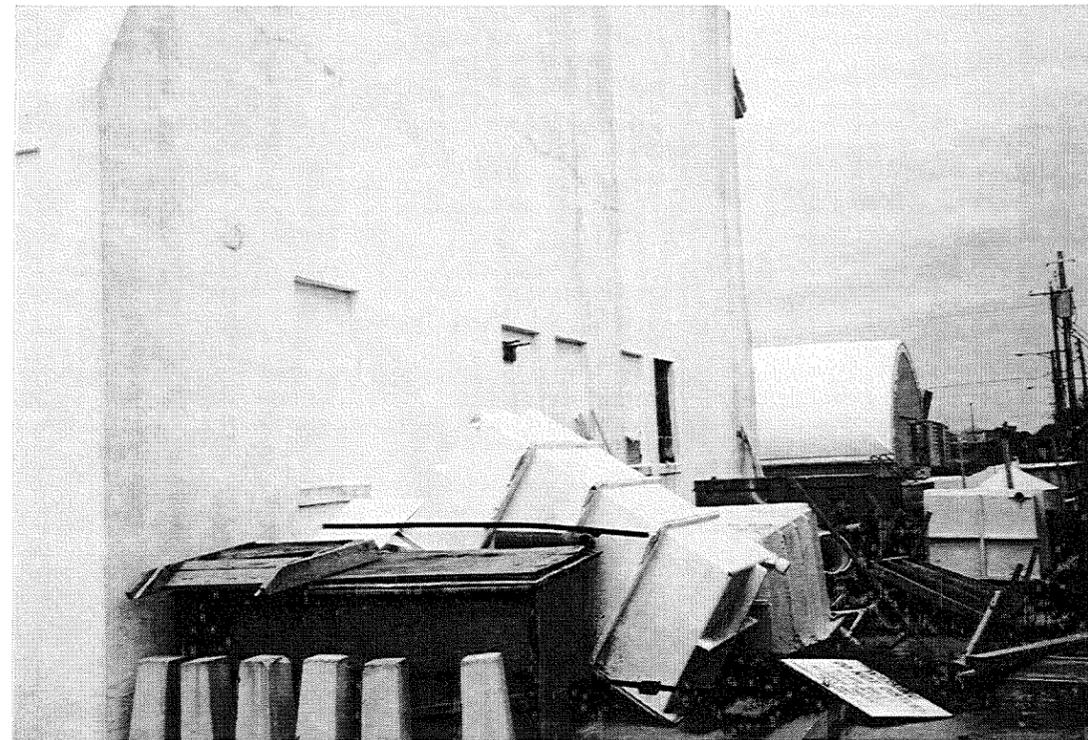
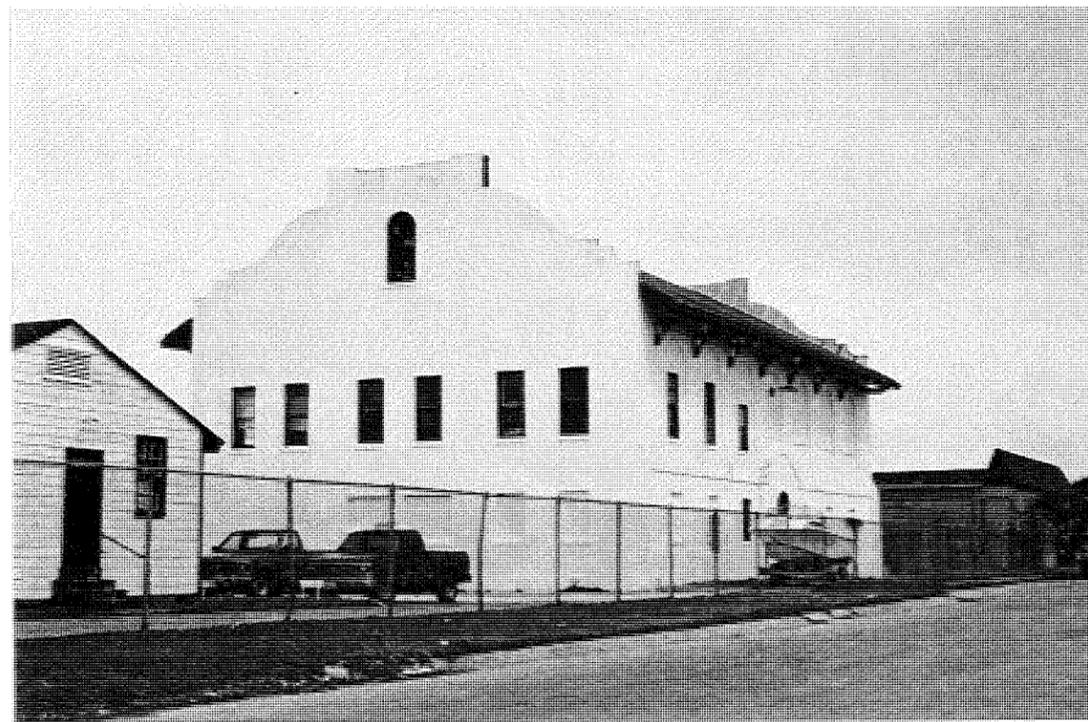
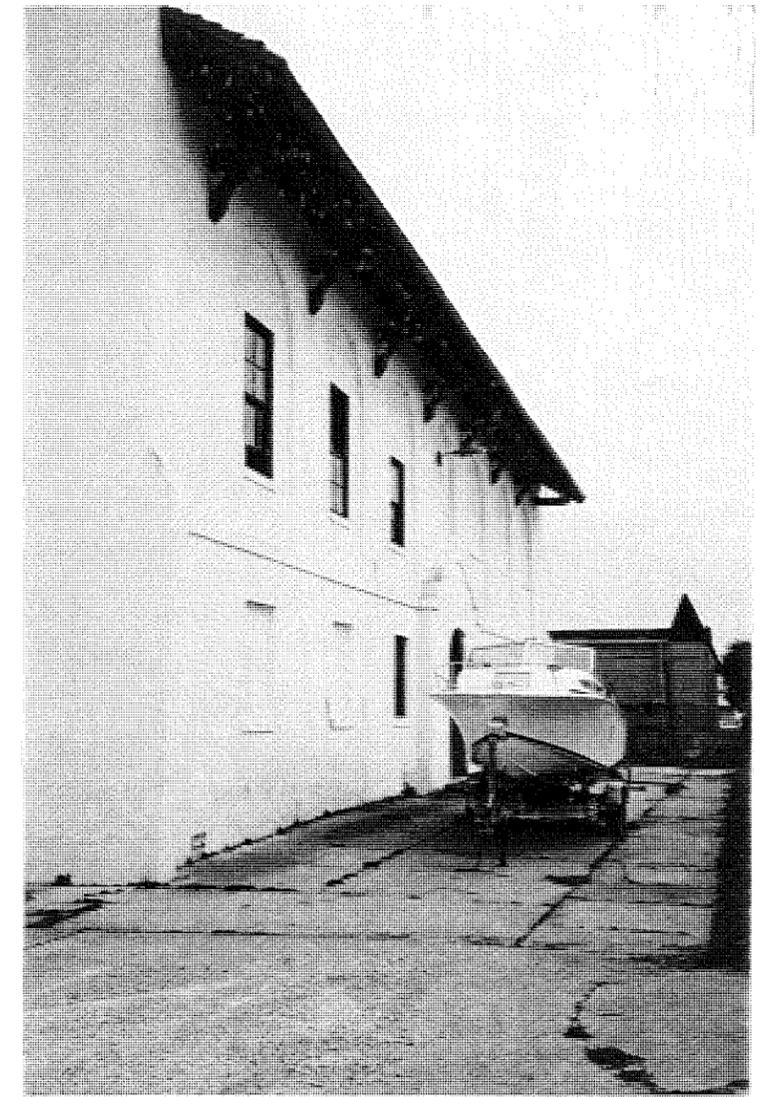
CURRENT PHOTOGRAPHS - EXTERIOR

- The first floor concrete slab will need to be replaced (or otherwise substantially altered).
- The exterior of the building is in good condition. Significant historic features appear to be generally intact and are quality construction - tile roofs, concrete walls, etc.
- The significant historic features on the interior of the building are in fair condition - wood flooring and bead board ceiling;; while others are in fair poor condition - plaster ceiling and wood paneling and trim finish.

- All wood finishes are restorable.
- Most plaster ceiling finishes will need to be replaced.

- **Windows:** All of the windows will be repaired or replaced to match the original drawings and to provide insulated glazed units. All original openings are to be restored, except those which will be altered to provide door openings to meet egress requirements.

- **Storm Protection:** Hurricane shutters similar to those on the other buildings or storm screens similar to those manufactured by Exeter Products shall be used to protect all windows. The Exeter "Storm Screens" are recommended due to the ornamental nature of the windows on this building.

- **Walls:** The original walls finishes are to be retained, except where removal of unsound material makes the retention of materials impractical.
- **Floors:** Retain the second floor and mezzanine floor finishes. The first floor finishes will be lost due to the replacement of the failed floor slab.

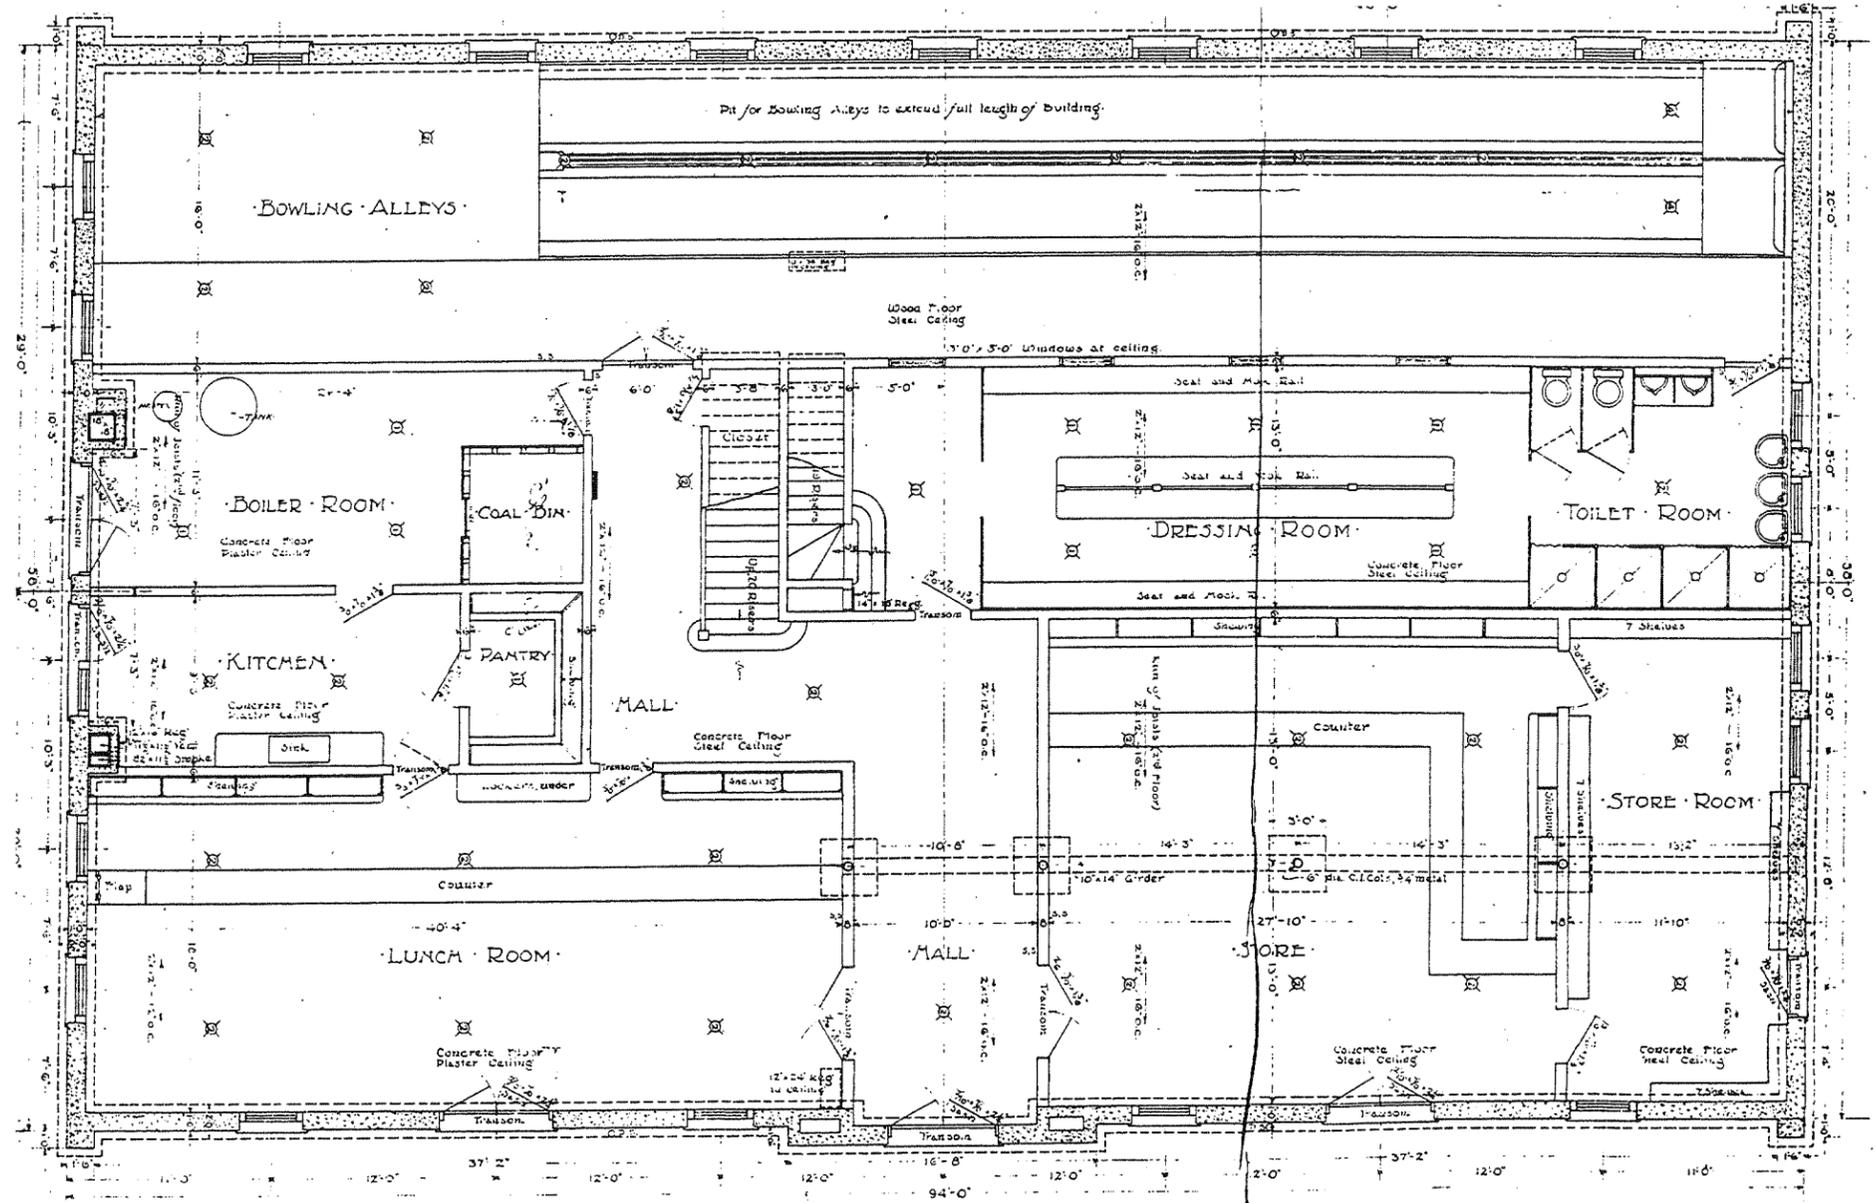
HISTORIC / ORIGINAL DRAWINGS - FIRST FLOOR PLAN

174-A  
SHEET NO. 1  
CONSTRUCTION SHEETS  
OST EXCHANGE & GYMNASIUM  
JAN 1909

FIRST FLOOR PLAN  
SCALE 1/4" = 1 FOOT

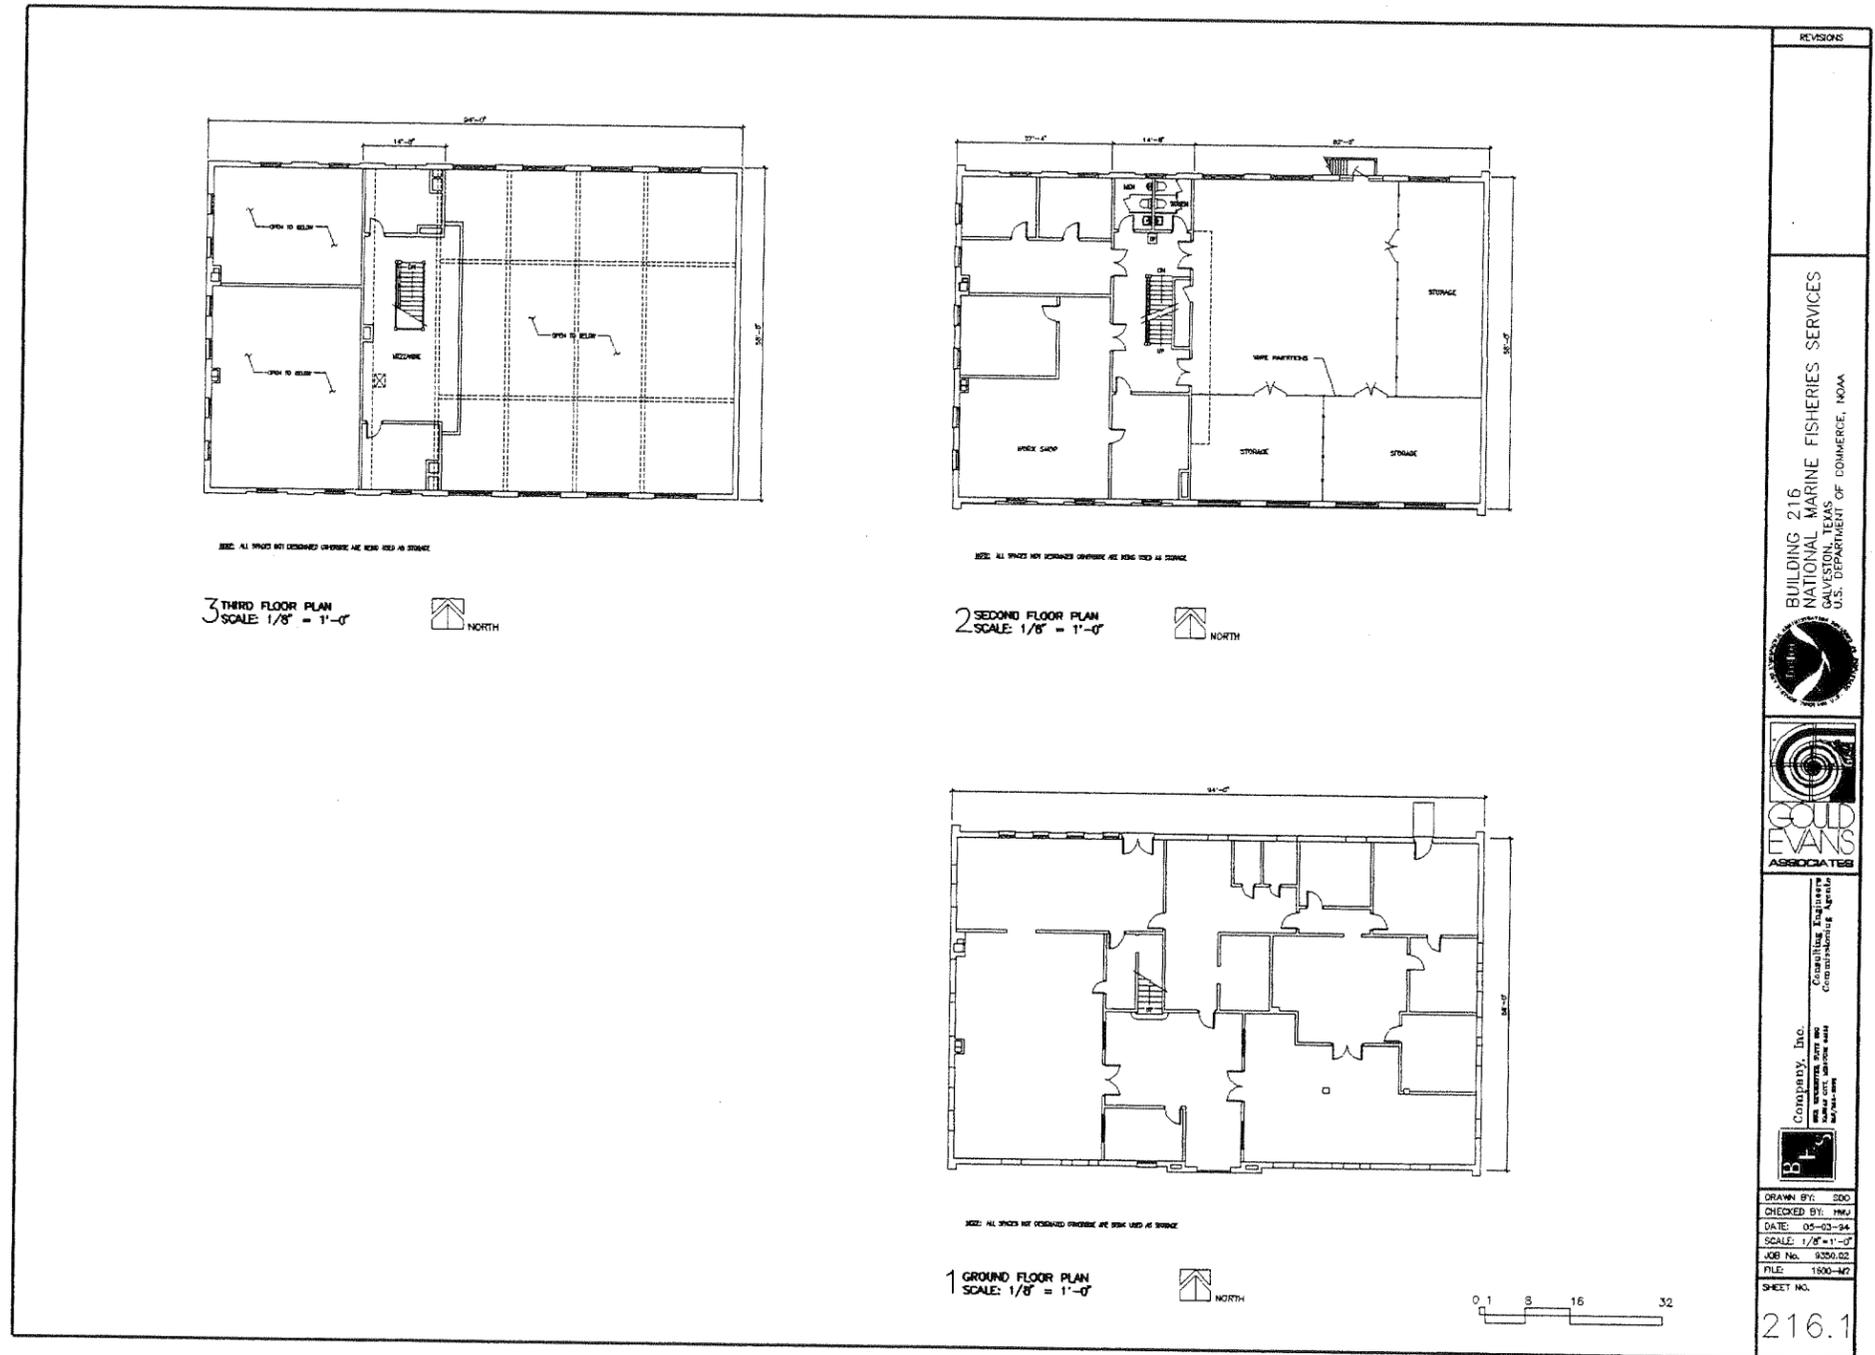
CURRENT FLOOR PLANS

- This building's structural columns and walls allow for a variety of functions to be fitted into the first and second floors without obstruction or destruction of historic fabric, however since the first floor will have to be replaced most of the first floor walls will be lost as well.

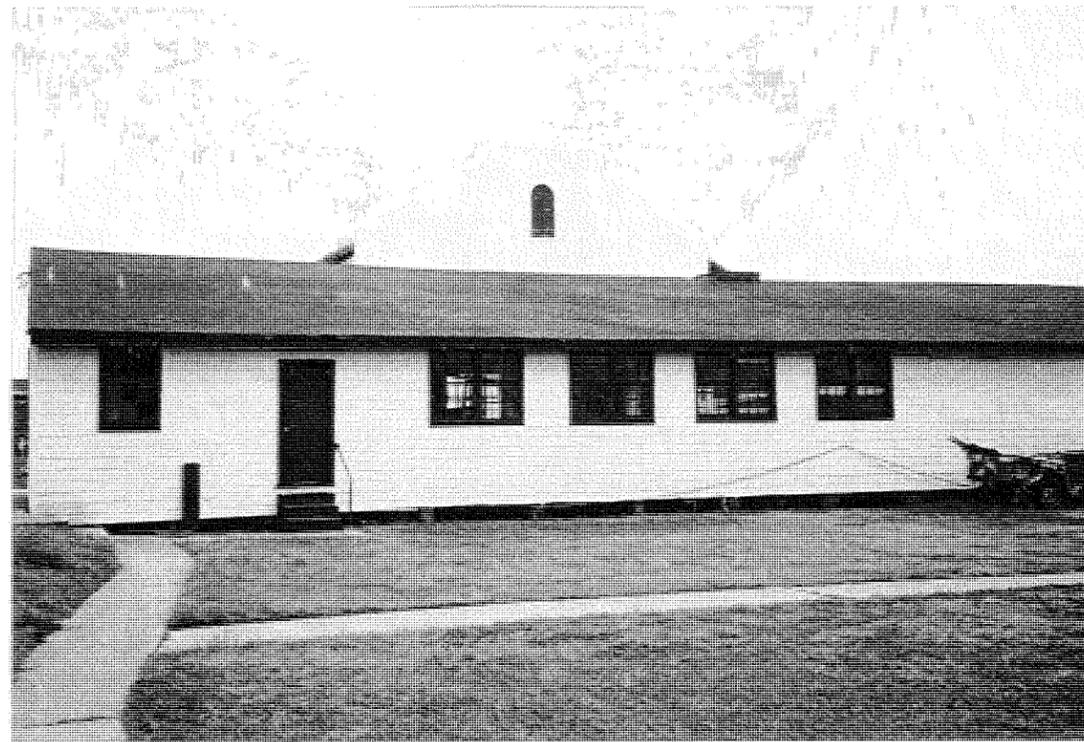
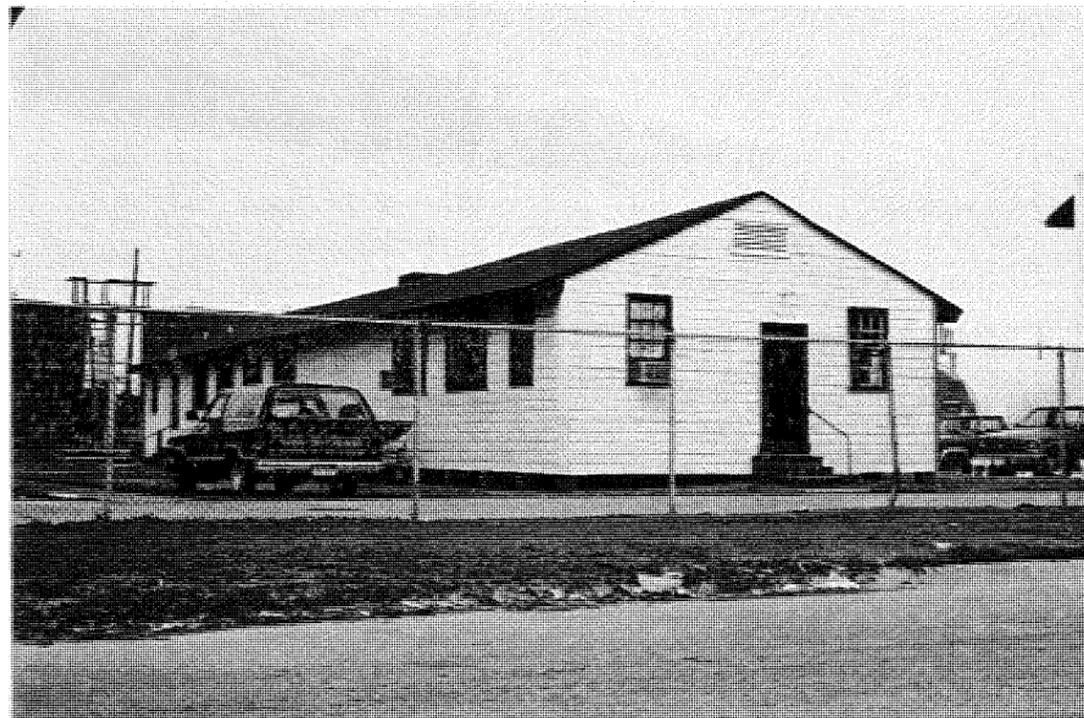
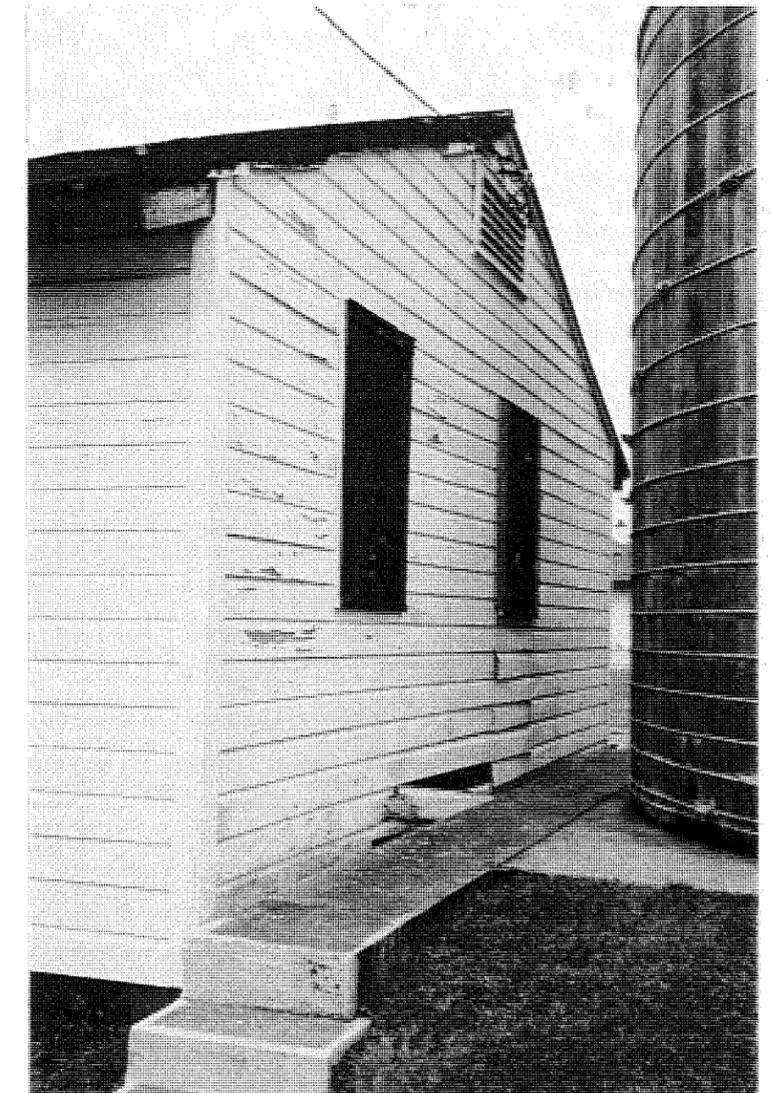
CURRENT PHOTOGRAPHS

- The floor structure is in poor condition.
- The exterior of the building is in poor condition.
- The interior of the building is in poor condition.

The historic configuration is still very much intact. Previous reports have documented structural problems with the floor and noticeable sagging of the facades indicates foundation problems. Due to the building's wood construction and age, it appears ill-suited for any function currently programmed for the site for the foreseeable future.

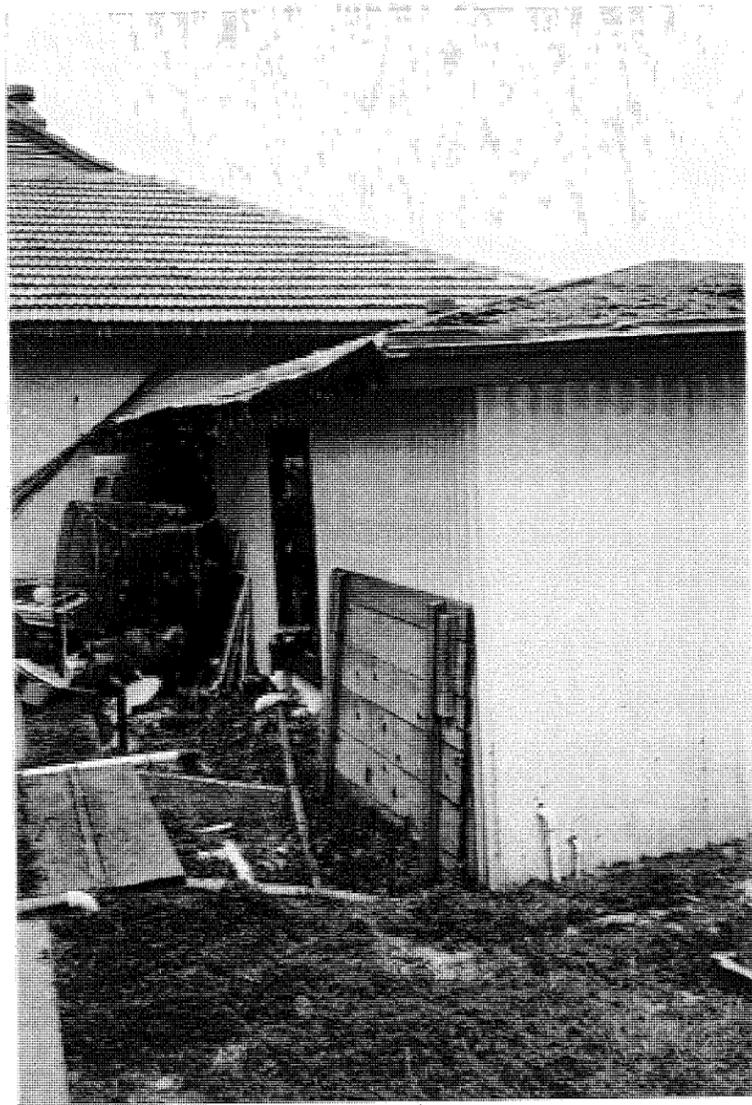
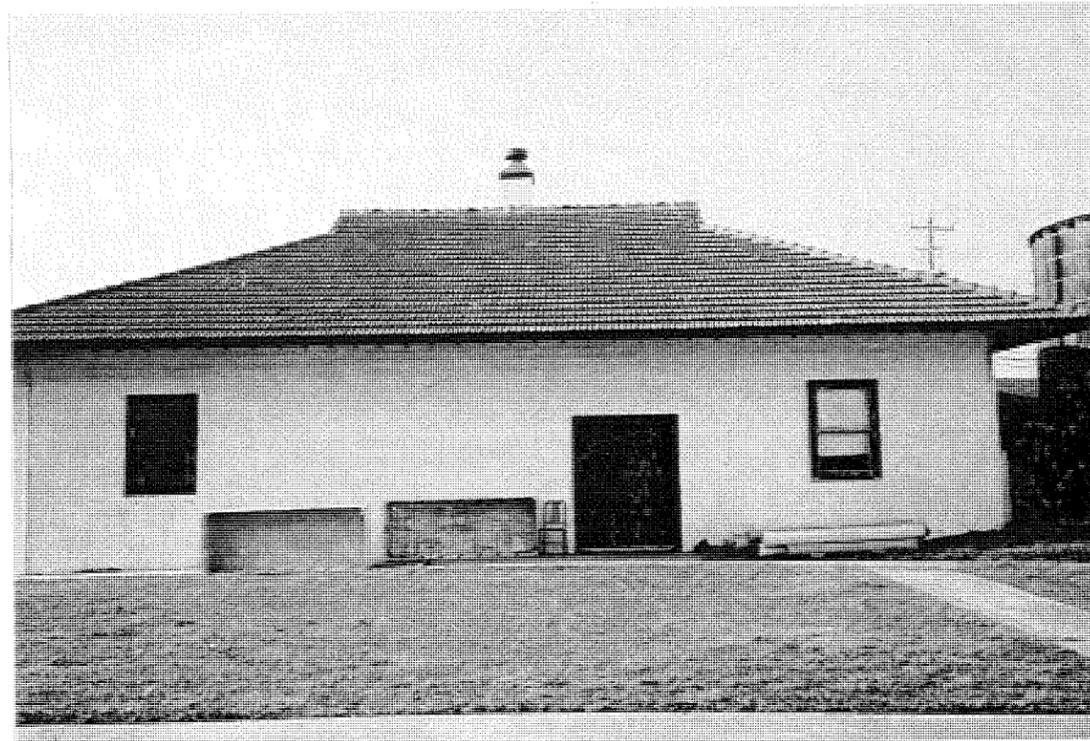
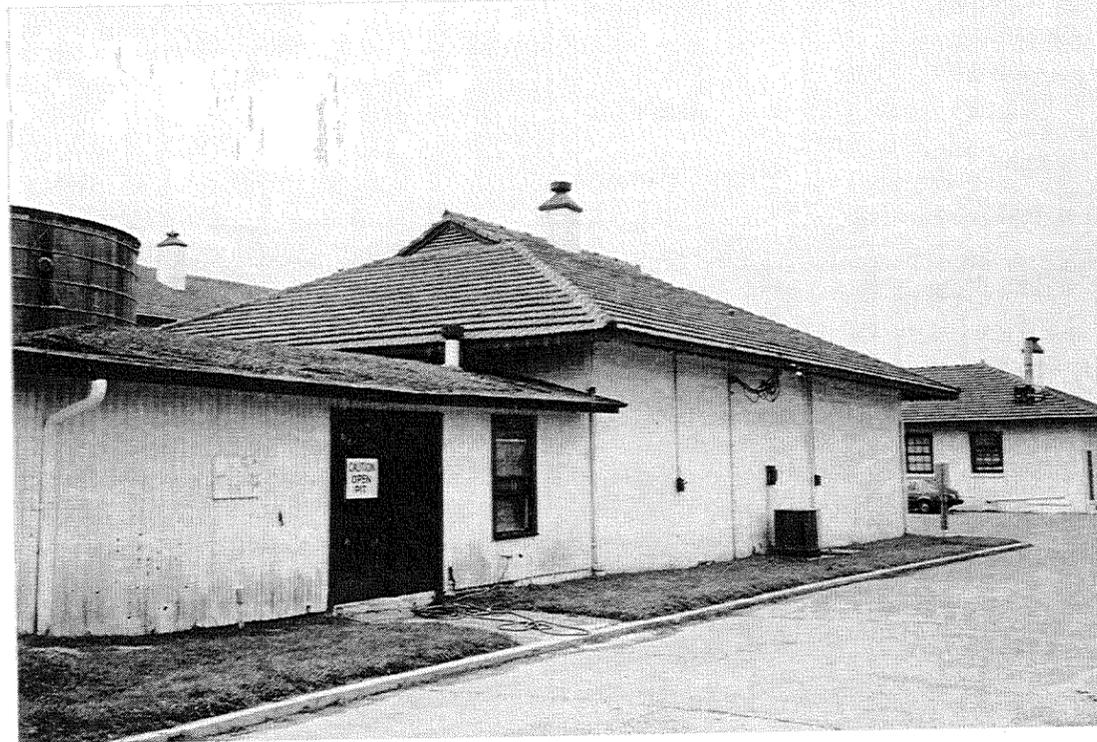
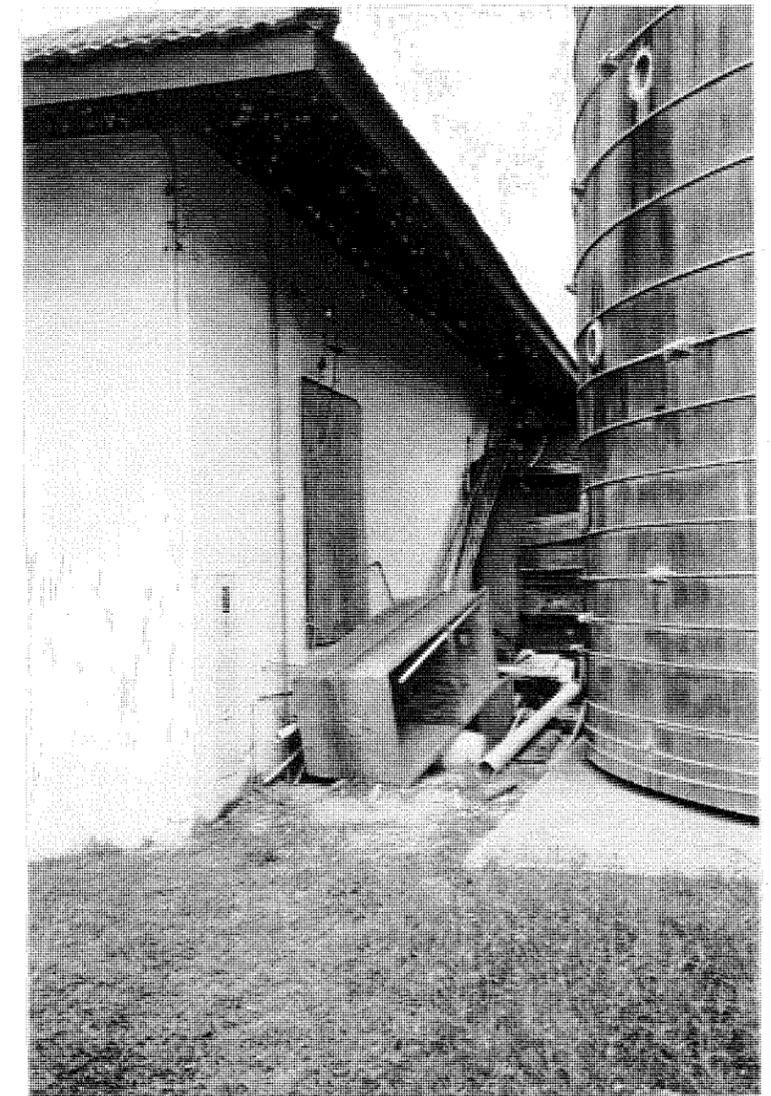
CURRENT PHOTOGRAPHS

- The exterior of the building is in good condition. Significant historic features appear to be generally intact and are quality construction - tile roofs, concrete walls, etc.
- The interior of the building is in fair condition.

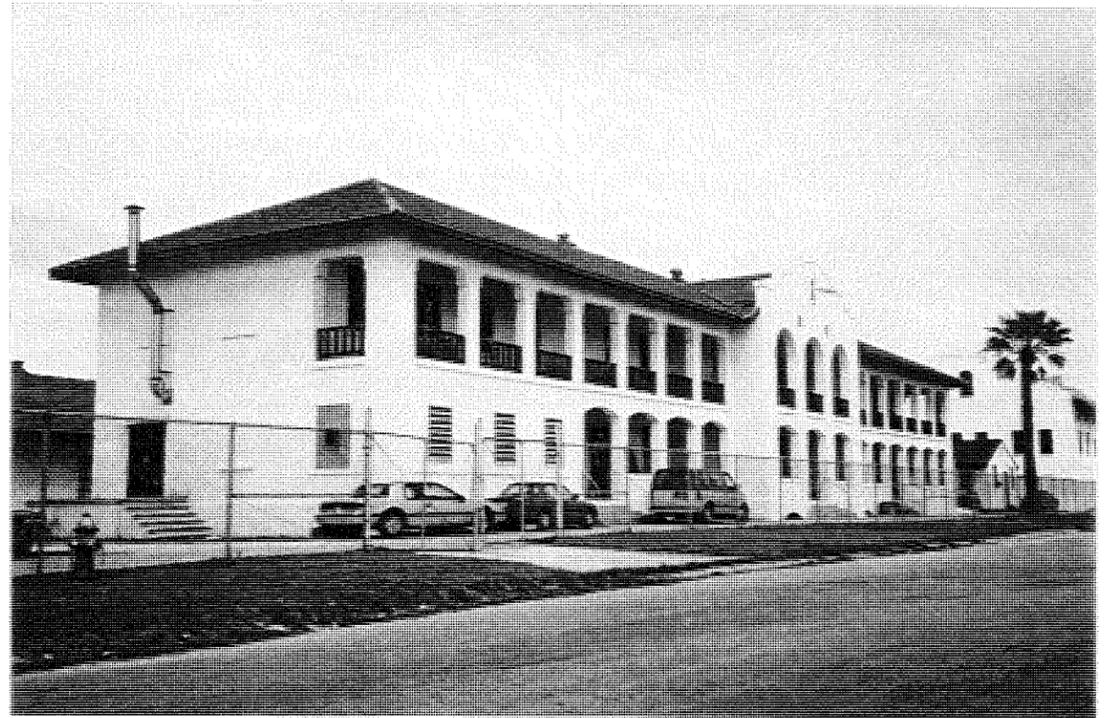
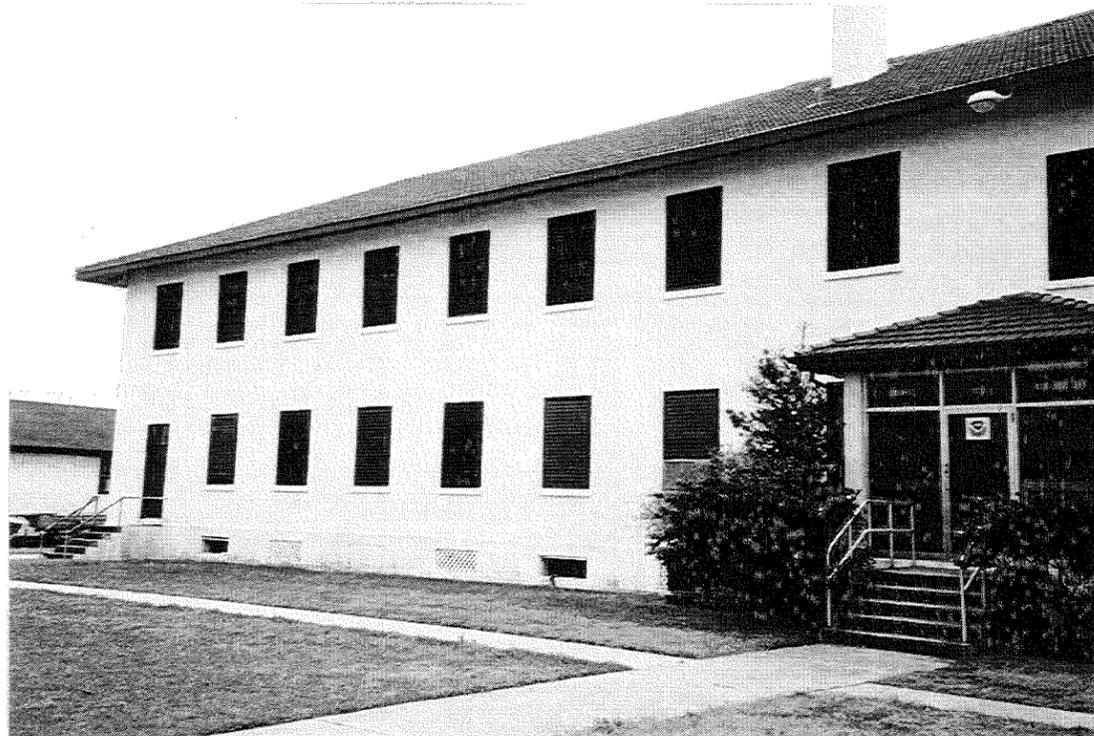
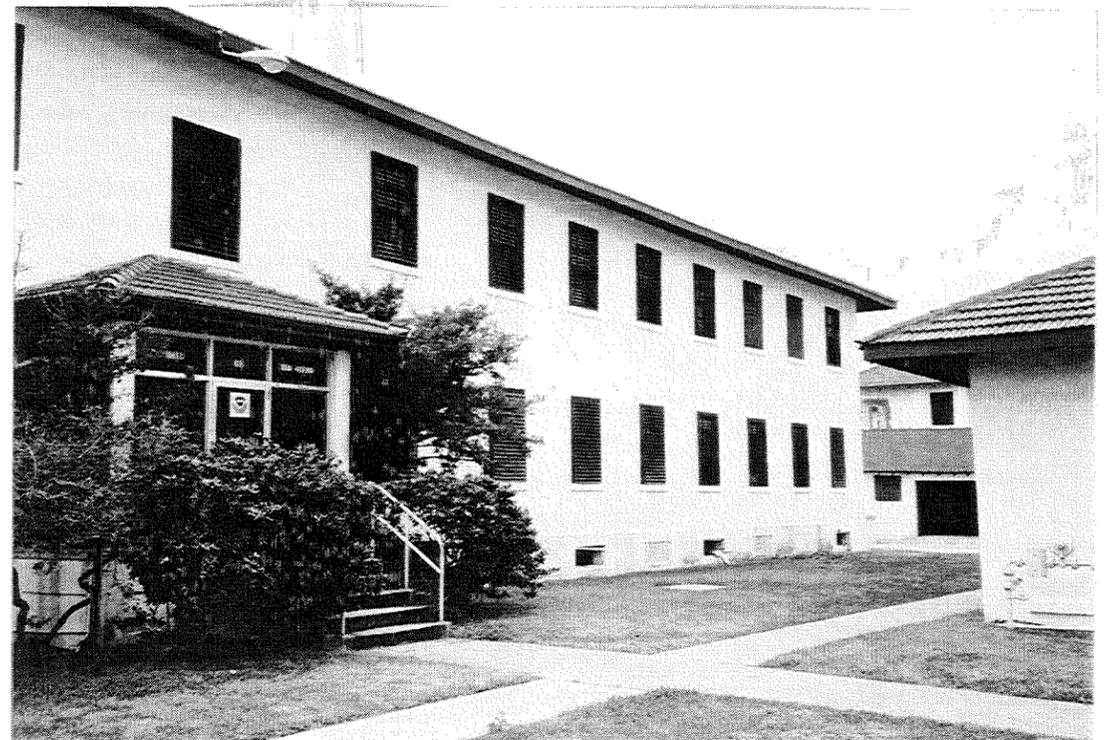
CURRENT PHOTOGRAPHS

- The first floor concrete slab will need to be replaced (or otherwise substantially altered).
- The exterior of the building is in good condition. Significant historic features appear to be generally intact and are quality construction - tile roofs, concrete walls, etc.
- The interior of the building is in fair condition, with most of the original finished covered over.

Replace the failed second floor porch ceiling (Also see "Systems").

Replace the existing 1968 railings with railings which match the original design intent while conforming to current code requirements.

Retain the second floor and mezzanine floor finishes. The first floor finishes will be lost due to the replacement of the failed floor slab.

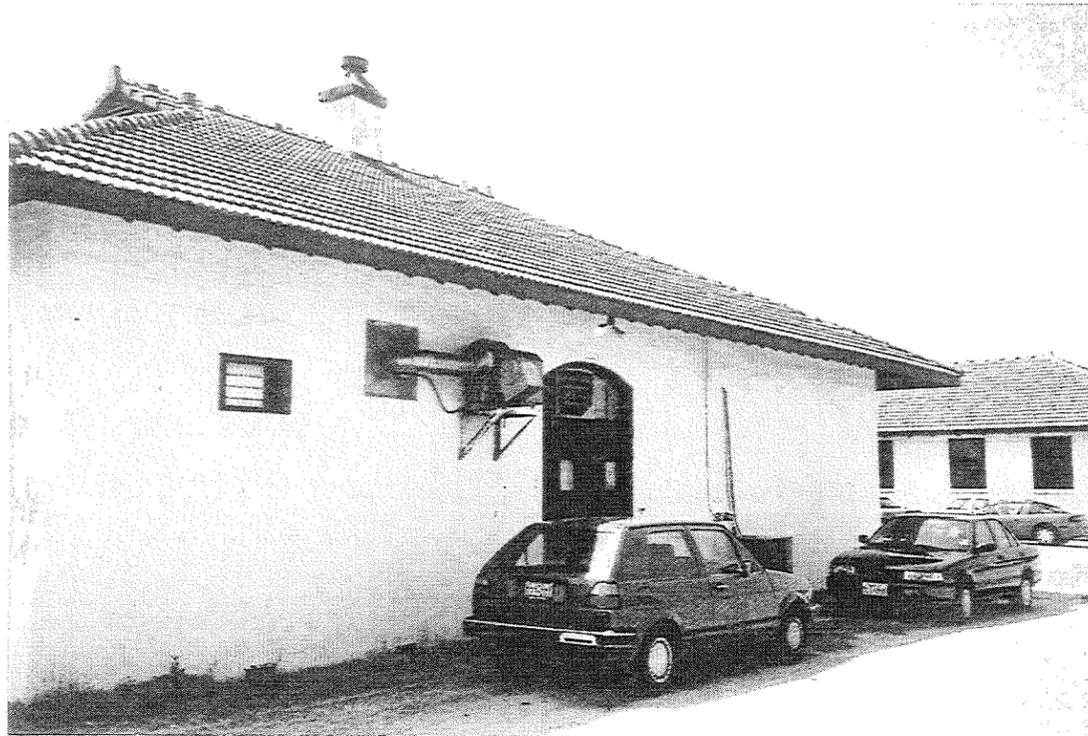
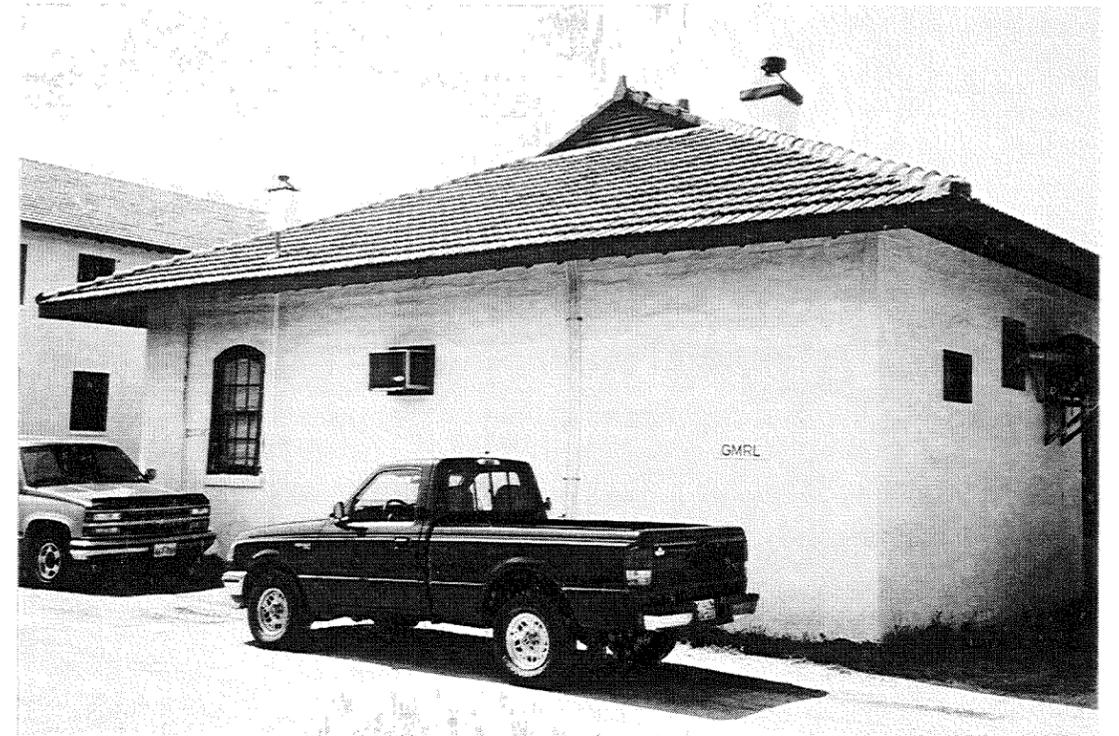
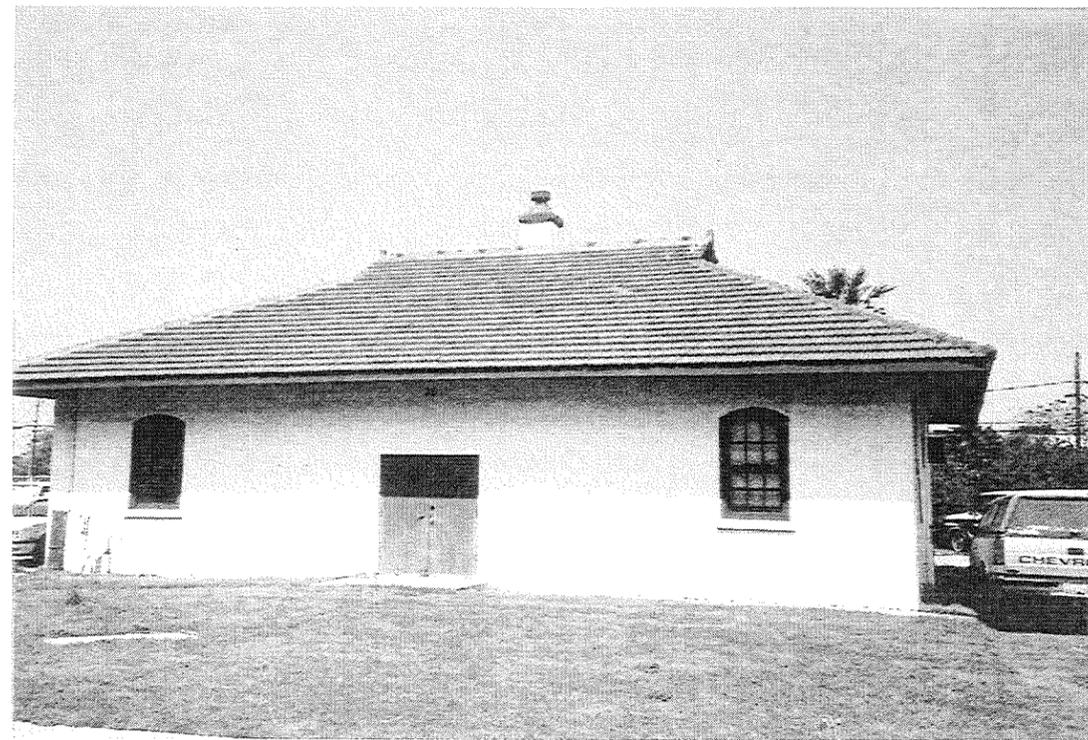
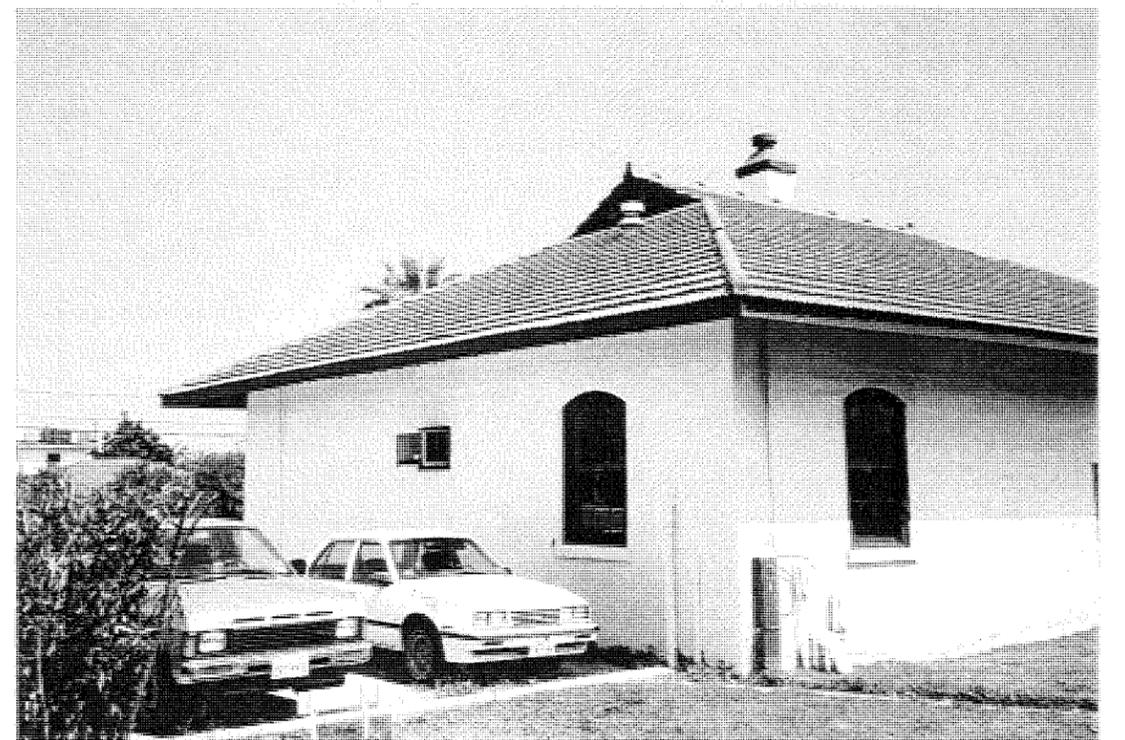
CURRENT PHOTOGRAPHS

- The exterior of the building is in good condition. Significant historic features appear to be generally intact and are quality construction - tile roofs, concrete walls, etc.
- The interior of the building is in good condition.

The stepped floor condition between what was originally the porch, barber and tailor spaces and the main body of the building will need to be leveled by raising the aforementioned spaces to provide accessibility.
